**Flood Control Project Maintenance
Levee Inspections**

Maintenance Issue Types Only, Levee Inspection Report By Mile - Fall 2018

Sutter Maintenance Yard Hamilton Bend

Waterway	Bank	Unit Miles	Inspection Start/End	Inspector
Unit No. 01 Feather River Hamilton Bend	Right	3.39	09/06/2018 09/06/2018	Sterling York

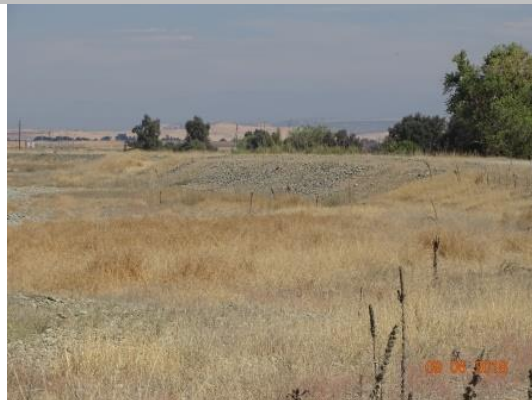
Photo 1 of 1 : FA_2018_ST0005_289_3_20181003_00015.jpg

LM Start	0.02	Rating **	A	Issue No.	3
LM End	1.21	Issue Type +	Ma	Location *	LS
Category	Earthen Levee			GPS Latitude/Longitude	
				Start	End
Item	Vegetation			39.439960 °	39.456723 °
				-121.641439 °	-121.639323 °
DWR ID	DWR_ST0005_01_f_2018_3				
Comment Code					
V1 : Control annual grass and weeds on the levee slopes and easements.					
Inspector Comment					
Maintained annual vegetation, this section is sprayed but not mowed due to the cobbles, Fall 2018.

View looking upstream landside of the maintained annual vegetation, this section is sprayed but not mowed due to the cobbles, Fall 2018.

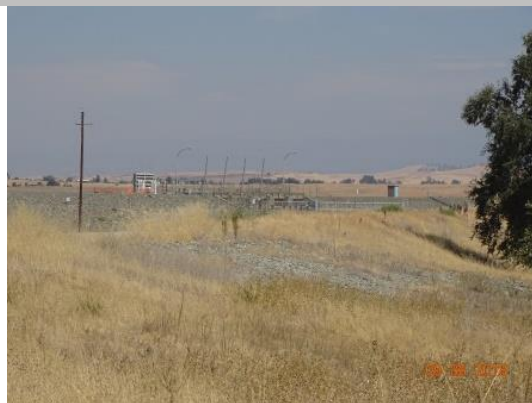
Photo 1 of 1 : FA_2018_ST0005_289_5_20181003_00016.jpg

LM Start	0.02	Rating **	A	Issue No.	5
LM End	1.21	Issue Type +	Ma	Location *	WS
Category	Earthen Levee			GPS Latitude/Longitude	
				Start	End
Item	Vegetation			39.439960 °	39.456723 °
				-121.641439 °	-121.639323 °
DWR ID	DWR_ST0005_01_f_2018_5				
Comment Code					
V1 : Control annual grass and weeds on the levee slopes and easements.					
Inspector Comment					
Maintained annual vegetation, this section is sprayed but not mowed due to the cobbles, Fall 2018.

View looking upstream waterside of the maintained annual vegetation, this section is sprayed but not mowed due to the cobbles, Fall 2018.

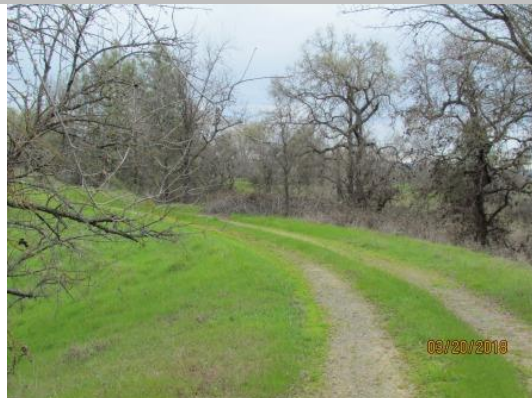
Photo 1 of 1 : FA_2018_ST0005_289_18_20180918_00007.jpg

LM Start	1.48	Rating **	U	Issue No.	18
LM End	1.99	Issue Type +	Ma	Location *	WS
Category	Earthen Levee			GPS Latitude/Longitude	
				Start	End
Item	Trim / Thin Trees			39.458053 °	39.461949 °
				-121.636300 °	-121.629563 °
DWR ID	DWR_ST0005_01_s_2017_18				
Comment Code					
T3 : Trim and thin trees to allow visibility of the ground and room to flood fight.					
Inspector Comment					
From Levee Mile 1.38 to 3.39 has never been maintained by the LMA.

View looking upstream of thick trees and vegetation blocking visibility on waterside, looking downstream. Spring 2018.

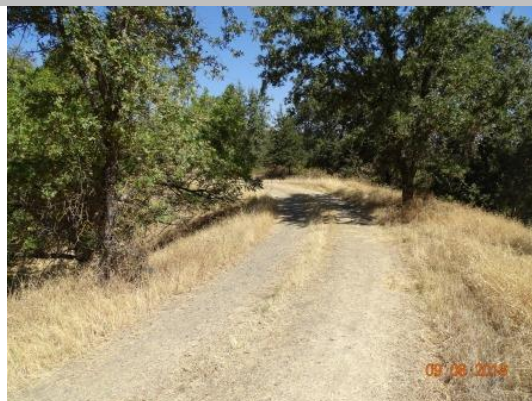
Photo 1 of 1 : FA_2018_ST0005_289_11_20181003_00014.jpg

LM Start	1.48	Rating **	U	Issue No.	11
LM End	3.25	Issue Type +	Ma	Location *	LS
Category	Earthen Levee			GPS Latitude/Longitude	
				Start	End
Item	Trim / Thin Trees			39.458055 °	39.470312 °
				-121.636300 °	-121.609242 °
DWR ID	DWR_ST0005_01_s_2017_11				
Comment Code					
T3 : Trim and thin trees to allow visibility of the ground and room to flood fight.					
Inspector Comment					
From Levee Mile 1.38 to 3.39 has never been maintained by the LMA.

View looking upstream landside and waterside of thick trees blocking visibility on landside, Fall 2018.

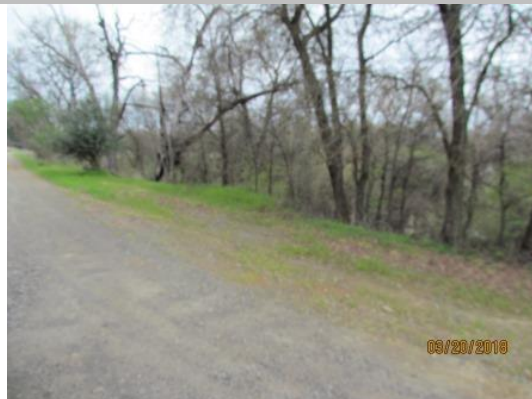
Photo 1 of 1 : FA_2018_ST0005_289_4_20180918_00001.jpg

LM Start	3.23	Rating **	M	Issue No.	4
LM End	3.27	Issue Type +	Ma	Location *	WS
Category	Earthen Levee			GPS Latitude/Longitude	
				Start	End
Item	Trim / Thin Trees			39.470063 °	39.470558 °
				-121.609264 °	-121.609215 °
DWR ID	DWR_ST0005_01_s_2013_4				
Comment Code					
T3 : Trim and thin trees to allow visibility of the ground and room to flood fight.					
Inspector Comment					
Small trees 4" in diameter at chest height should be removed before they get too big. From Levee Mile 1.38 to 3.39 has never been maintained by the LMA.

View looking upstream waterside of small trees 4" in diameter at chest height should be removed before they get to big, Spring 2018.
